Maryland
Department of
the Environment

Overview of Mountain Christian Church Drainfield System

C. T. Tien, Ph.D., P.E.
Deputy Program Manager
Wastewater Permits Program
Water and Science Administration
Maryland Department of the Environment

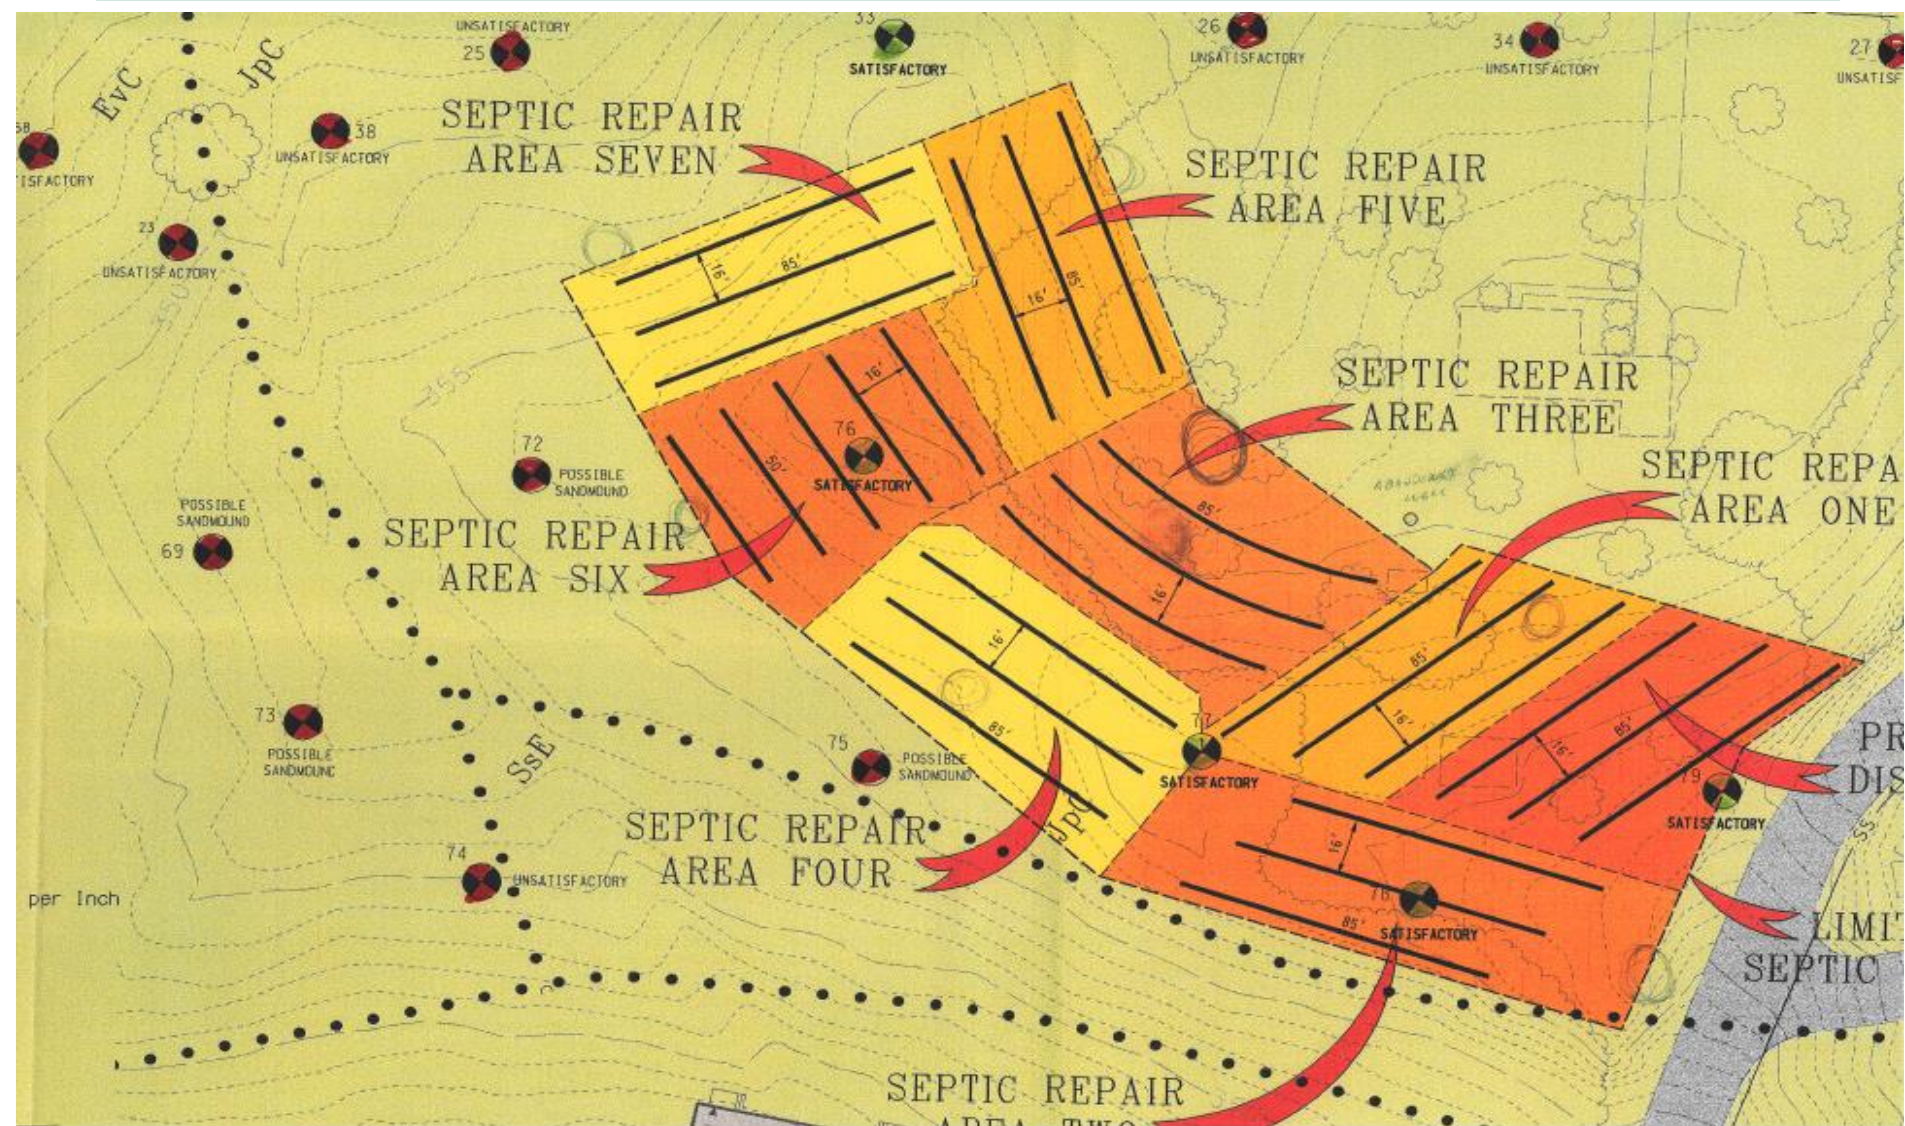
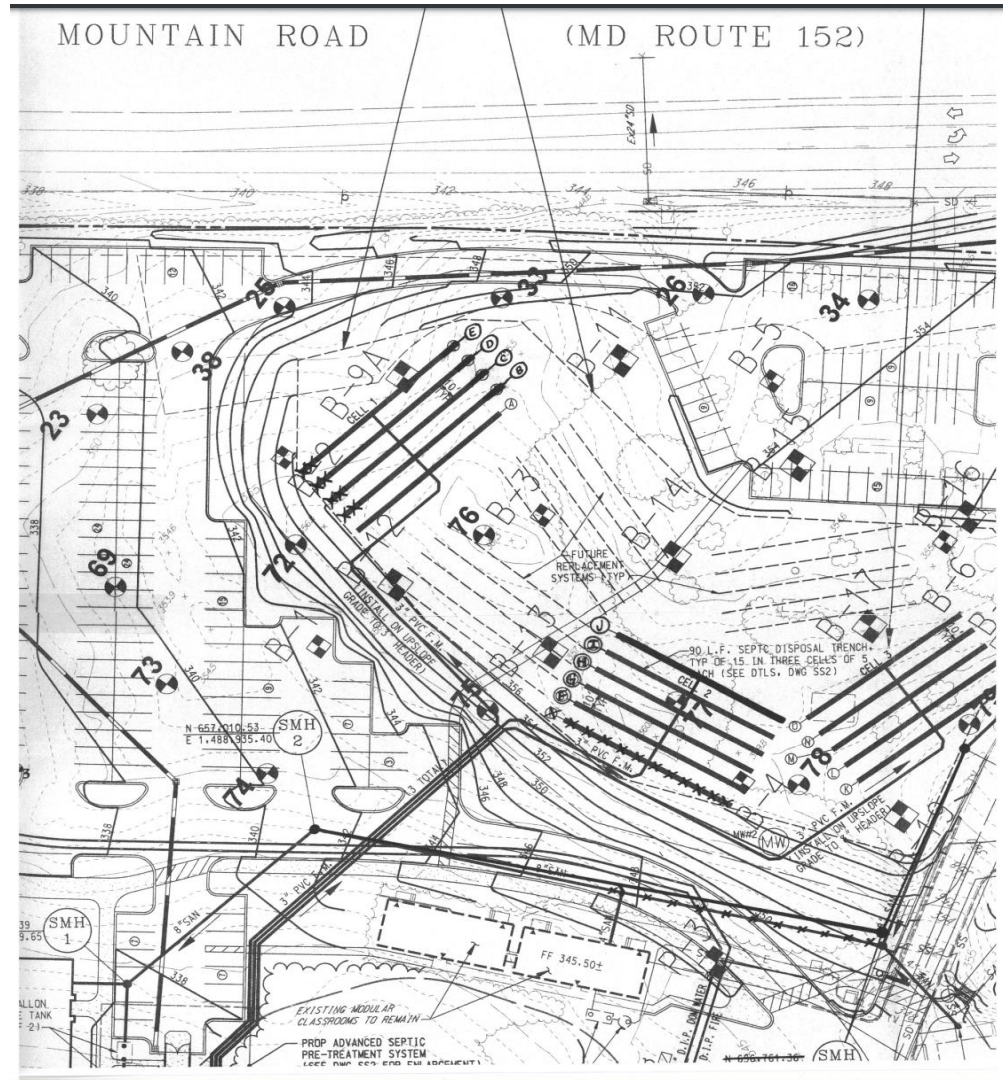
Locations of Existing Drainfield Site and Soil Test Pits

1. Although the drainfield is located in an area labeled as satisfactory soil testing in 2002, it is surrounded by unsatisfactory soil with clayey soil at shallow depth.
2. The “satisfactory” soil in the existing drainfield is likely impacted by a clay bottom as shallow as 13 ft (TP 76).
3. The soil in the existing drainfield and the nearby unsatisfactory soil form a clay bowl with the potential to accumulate effluent and cause overflow or seepage.
4. To date, two septic systems installed in the past at the Mountain Christian Church have failed (2003 and now) due to impermeable soil.

5. Options for a failing system include repair of onsite system, sanitary sewer connection, surface discharge permit.
6. Forcing the permittee to reduce an authorized permit flow volume is not considered a legal remedy.
7. Pump and haul is considered only a temporary solution until a new discharge or connection can be implemented.
8. The long history of the problems with the soils at this site led the Department to consider surface water discharge as an option.
